1994 Northridge Earthquake

Performance of Structures, Lifelines and Fire Protection Systems

NISTIR 5396

March 1994
Building and Fire Research Laboratory
National Institute of Standards and Technology
Gaithersburg, MD 20899

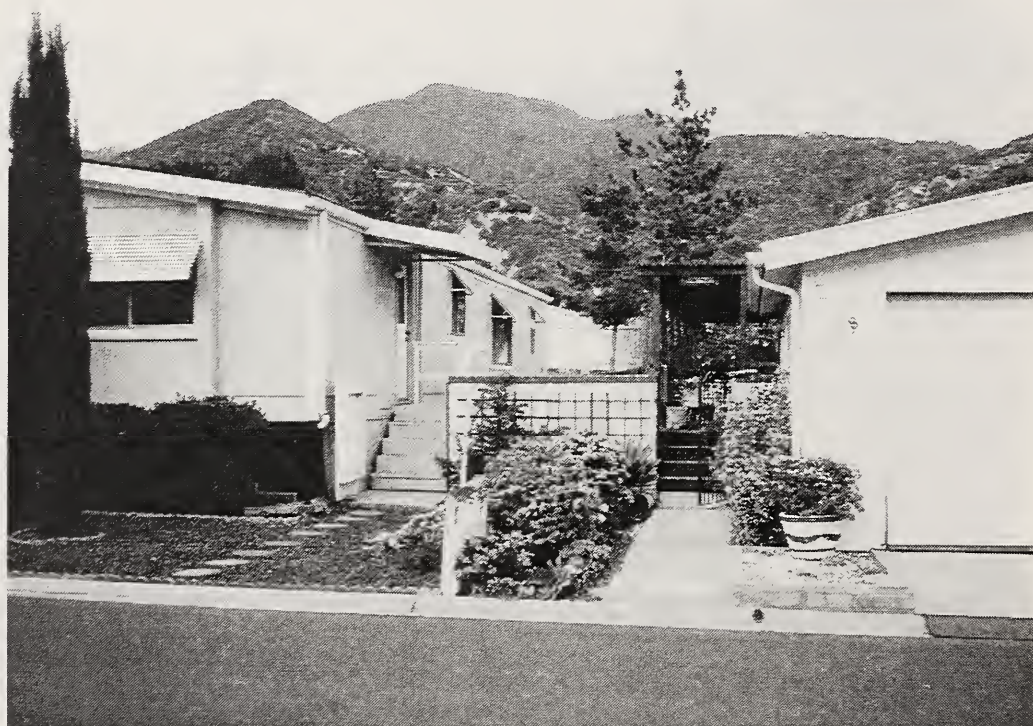
Building-to-building fire spread was limited to three manufactured housing developments (mobile home parks). Figure 6.8 shows the typical spacing between units in one of these developments. Figure 6.9 shows an area of the development destroyed by fire. Observations made at this development after the fires indicates the method of unit-to-unit fire spread was primarily through windows. Once a unit became completely involved in fire, the thermal radiation was sufficient to either cause the breakage of windows in an adjacent unit or ignite combustibles within the unit directly through the windows. The fire department reported low water pressure in the area which combined with multiple independent fires and limited resources hindered fire fighting operations. The fire spread was stopped either by separation such as roads and open areas or by fire department operations.

Figure 6.8 Typical unit spacing in a manufactured housing development.

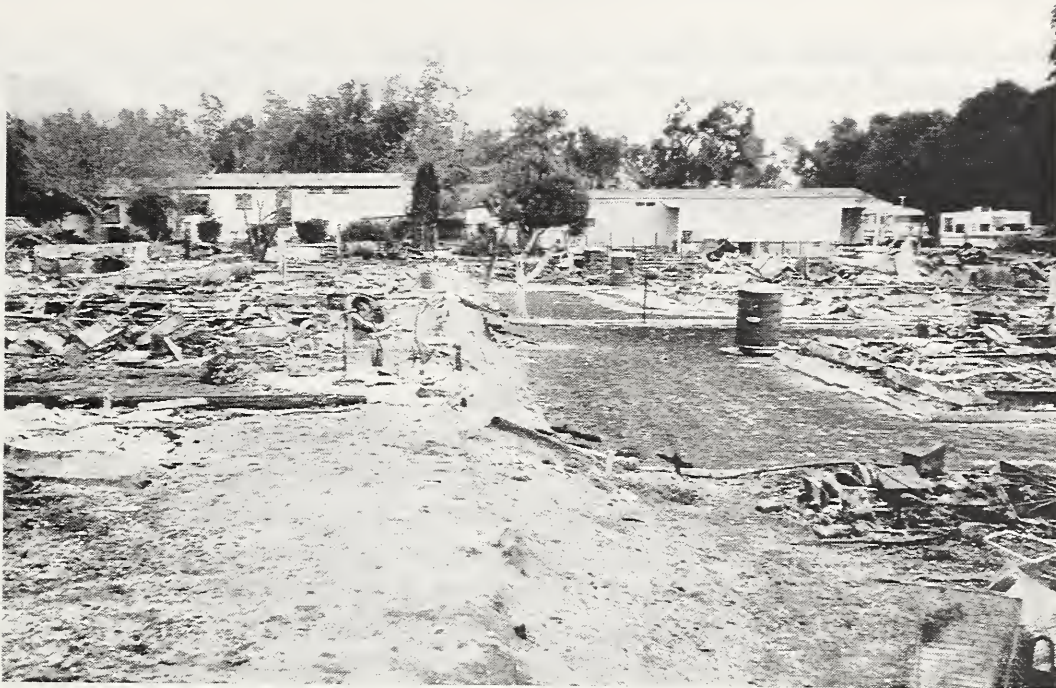
Figure 6.9 Impact of a multiple unit fire in a manufactured housing development.

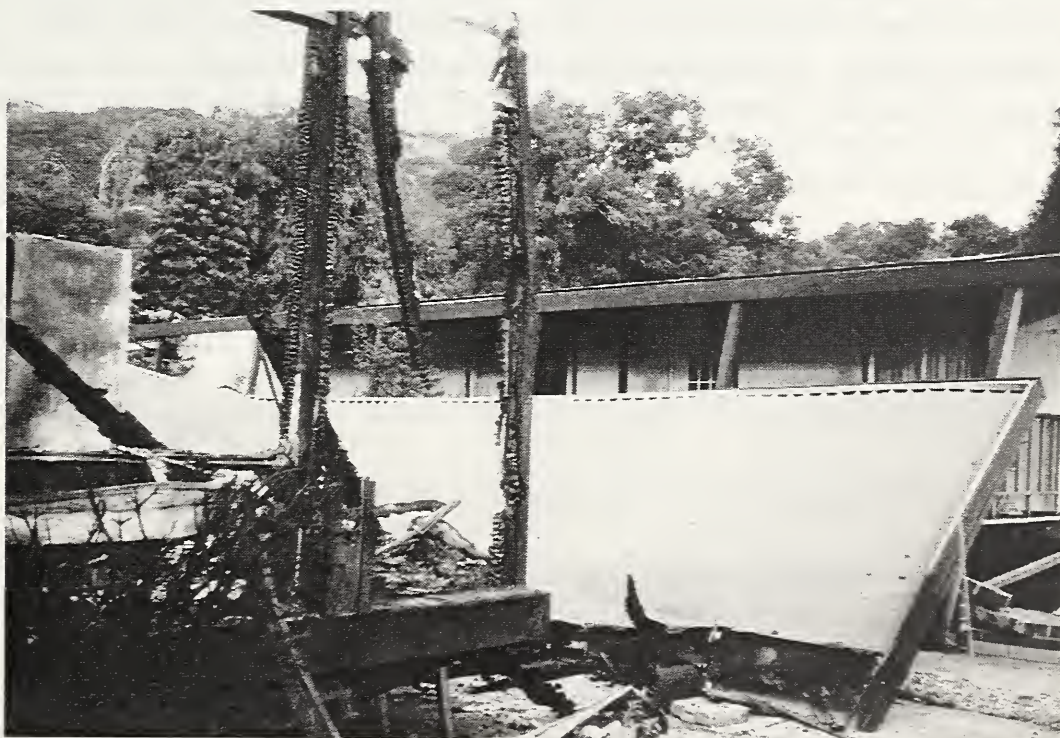
A unique aspect of the construction of these manufactured units played a role in limiting the spread and assisting fire department actions. As the units burned from the inside, the carport roofs collapsed from the building side, coming to rest on the outside supporting columns. In this way the carport roofs formed fire breaks as shown in Figure 6.10. Although these roofs would not necessarily have survived the fire by themselves, they reduced the fire exposure on adjacent units and thus enhanced fire fighting operations.

Figure 6.10 Collapsed roof which acted as a fire break in a manufactured housing development.
